New York State Department of Transportation

Yellow Flag NB2222W013

BIN: 1065318

Location: Span 158 – Stringer S1 at Pier 157 over 3rd Avenue Westbound

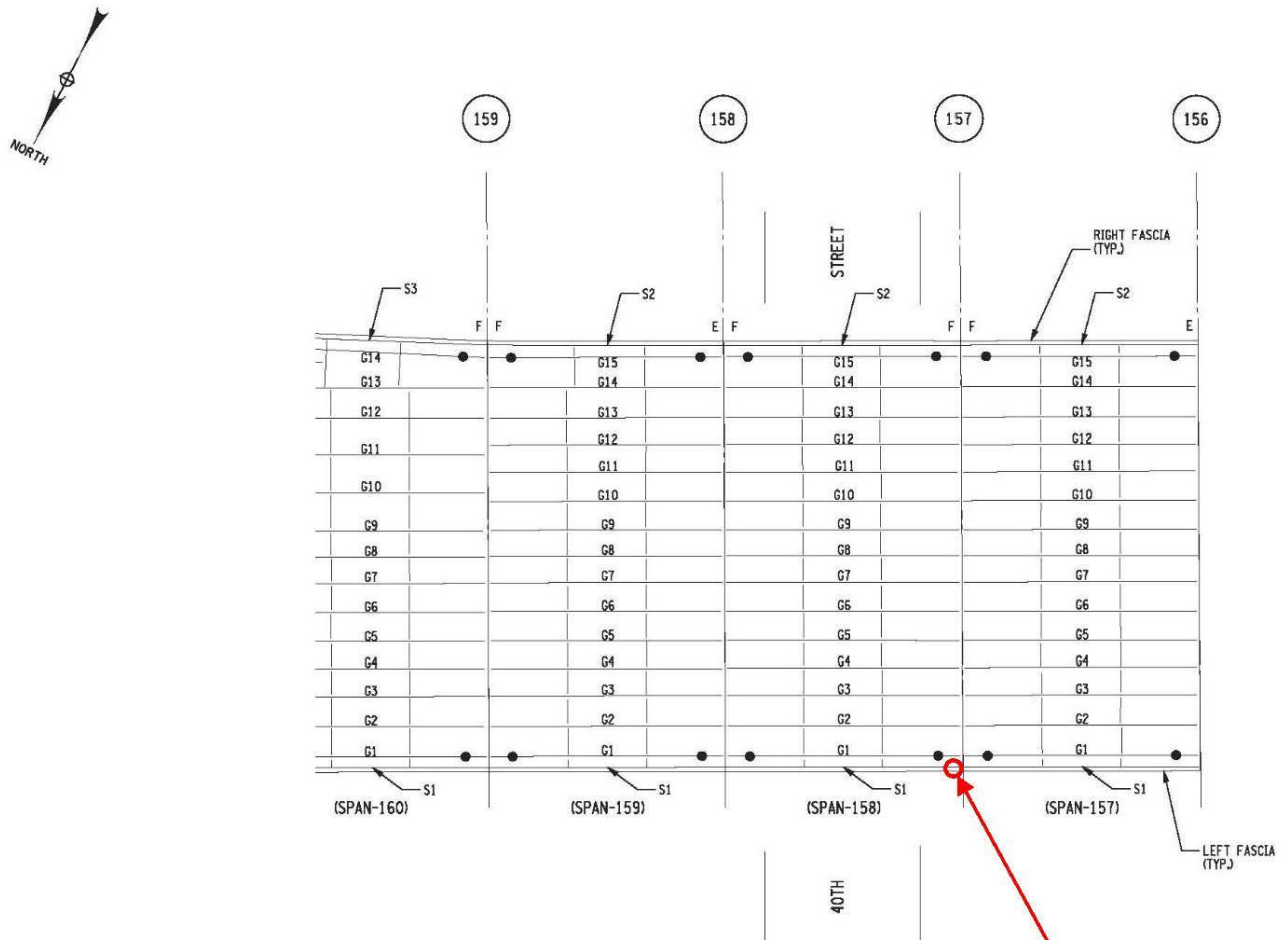
Photo Number: 1

**YELLOW FLAG
LOCATION
No. NB2222W013**

Attachment Description: SN 158 S1 at Pier 157 Framing Plan

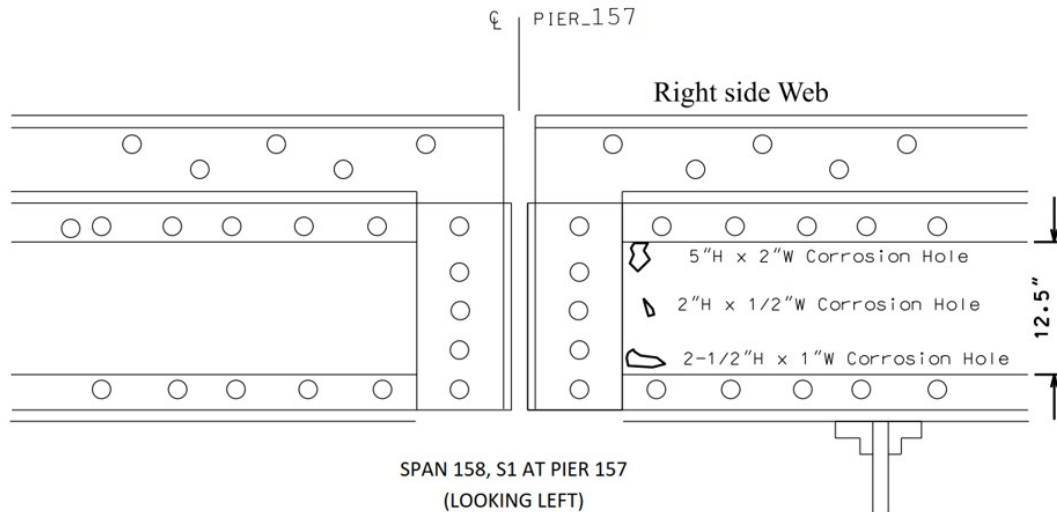
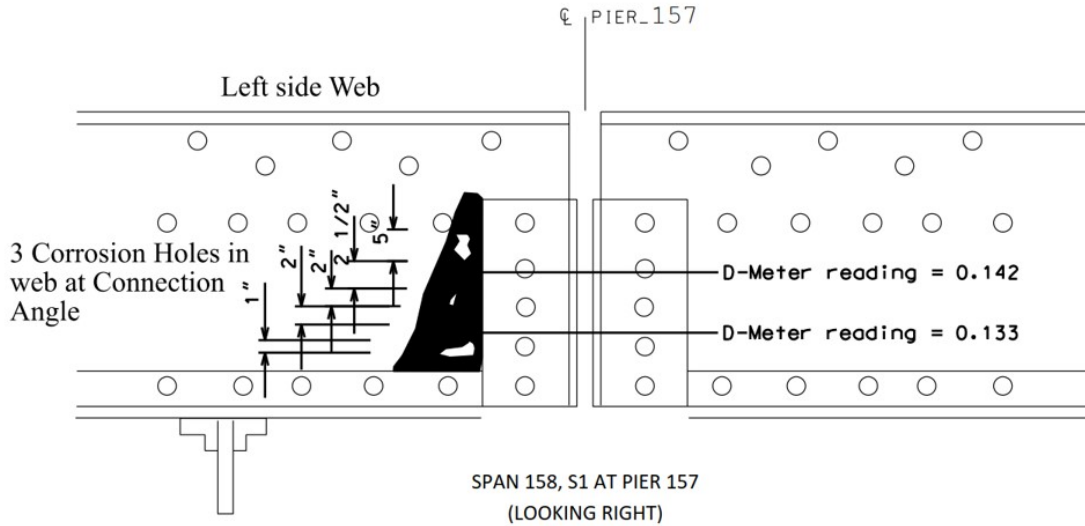
Photo Number: **2**Photo Filename: **BIN 1065318 - SN158 S1 at P157_R.jpg**Gowanus Expressway
2022 Biennial Inspection - Field SketchBIN: 1065318Team: SB / CTDate: 6/01/2022Span: 158Location: Stringer S1 at Pier 157

Description: Stringer S1, supporting the Railing/Parapet above deck, exhibits severe corrosion of the web with several large corrosion holes adjacent to the connection angles. The web height between the top and bottom flange angles is 12.5" H. The hole at the top of the web is 5" H x 2" W, at mid-web is 2" L x ½" W and lower web is 2-1/2" L x 1" H. D-Meter readings indicate remaining web between the upper corrosion holes as 0.142" and between the lower 2 holes as 0.133". Overall web section loss is approximately 87%. See sketch for details.

$$\text{Remaining Web} = (5" \times 0) + (2-1/2" \times 0.142) + (2" \times 0) + (2" \times 0.133) + (1" \times 0) = 0.621 \text{ in}^2$$

$$\text{Web Area} = 12.5" \times 0.385" = 4.81$$

$$\text{Web Loss} = (4.81 - 0.621) / 4.81 = 87\%$$

SCALE: N.T.S**Attachment Description: SN 158 S1 at Pier 157 Sketch**

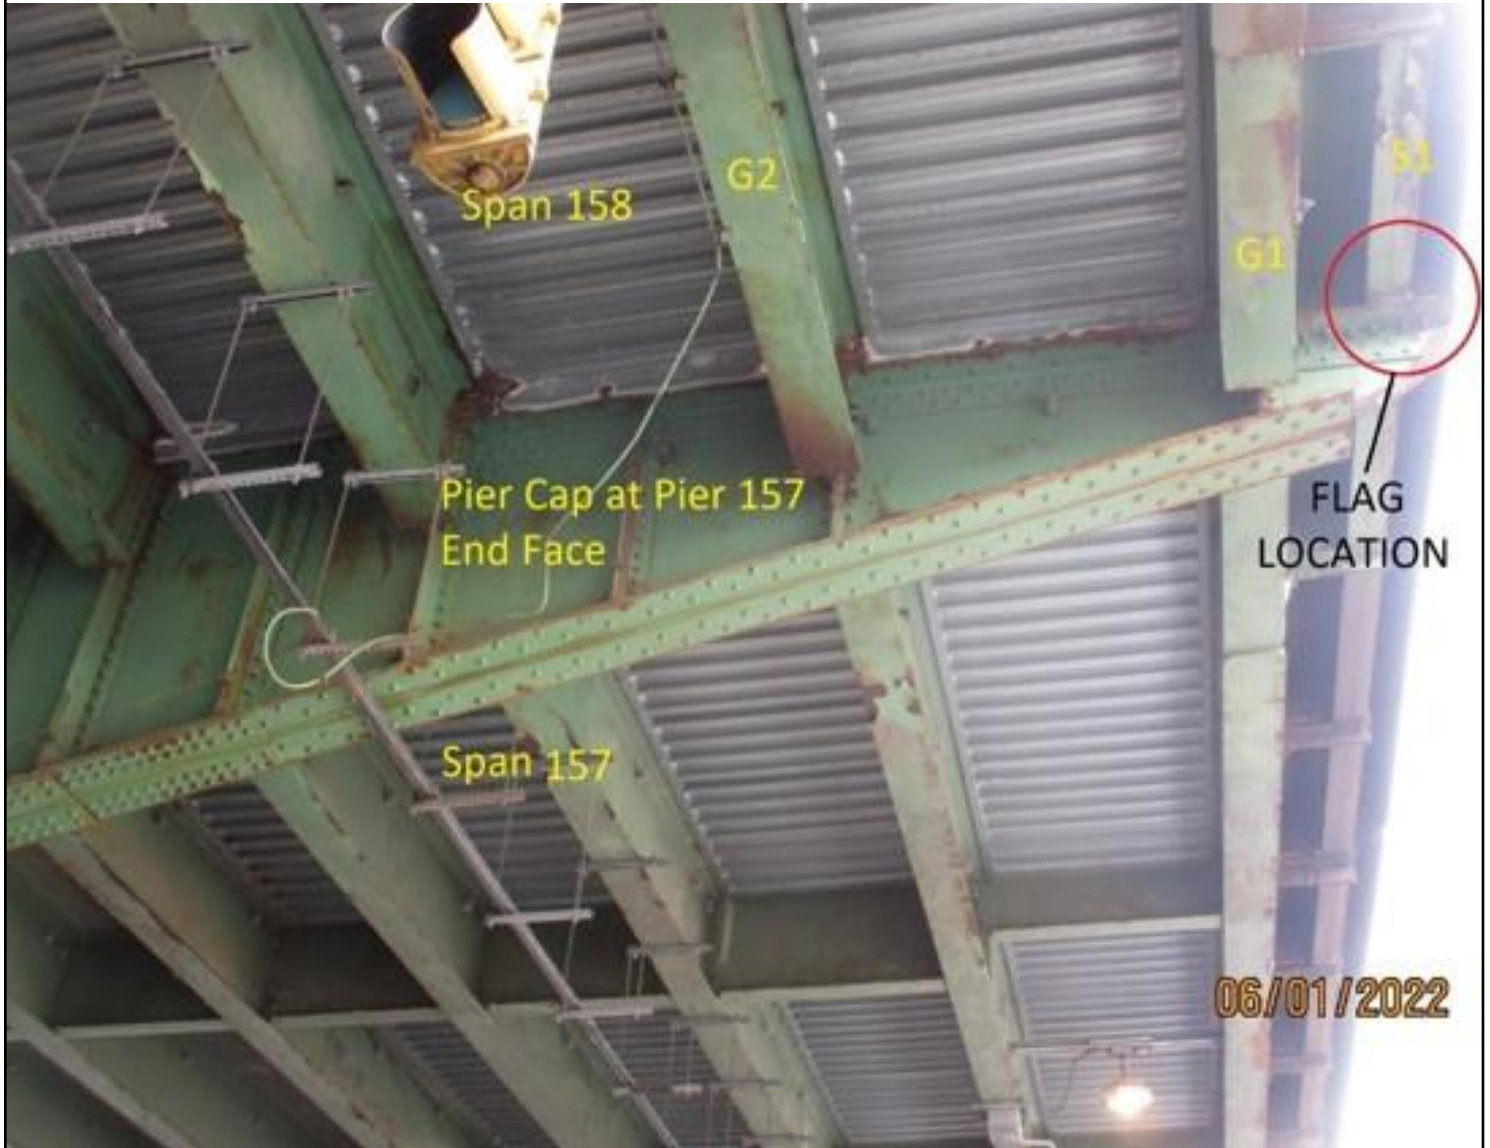
Photo Number: 3

Attachment Description: Photo 1: General view of Flag location at Pier 157. Looking begin.

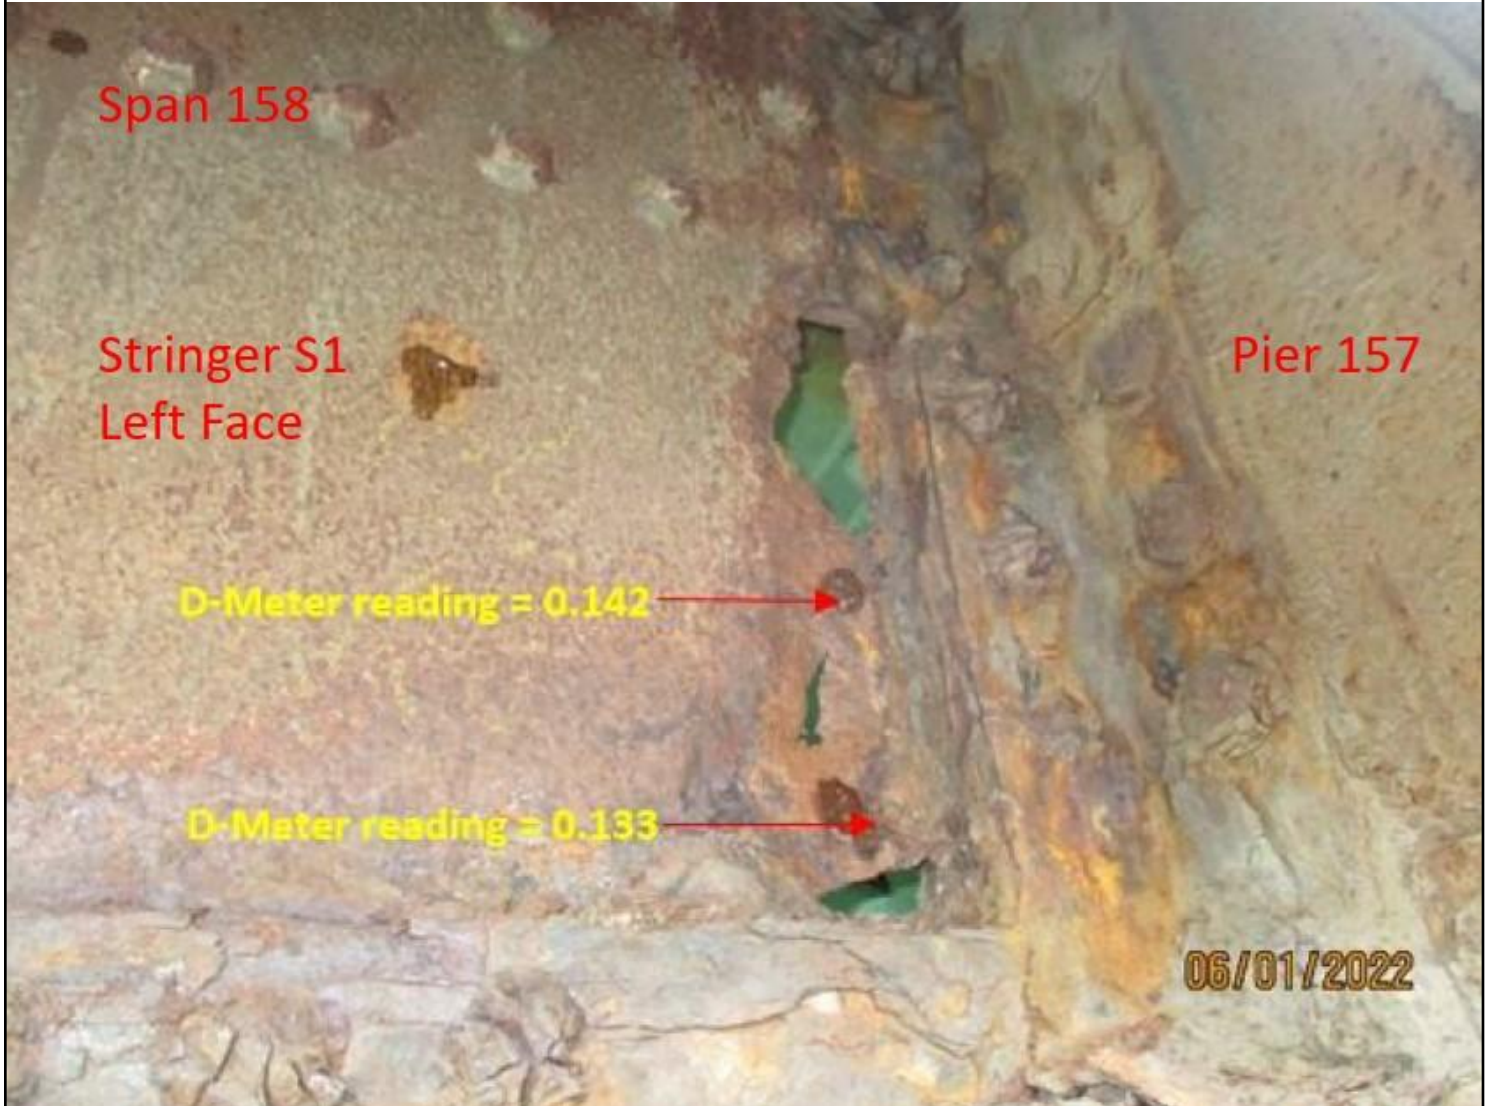
Photo Number: 4

Attachment Description: Photo 2: Span 158, Stringer S1 at Pier 157 - Corrosion holes at web of Stringer S1. Looking right

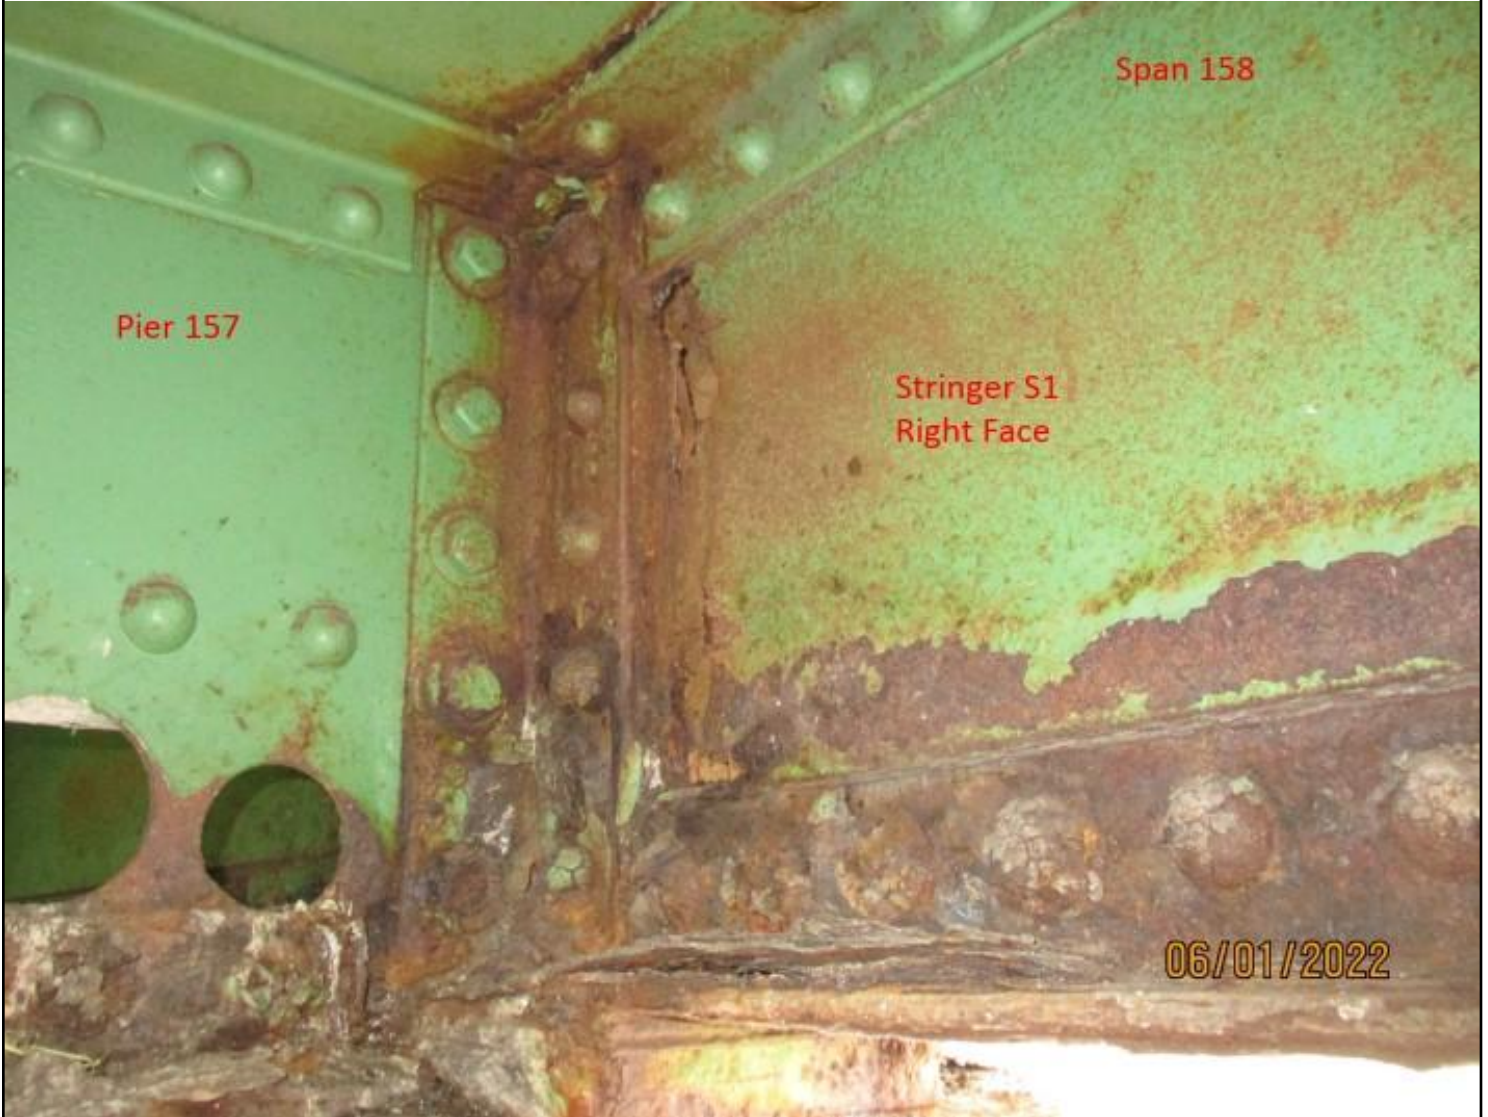
Photo Number: 5

Attachment Description: Photo 3: Span 158, Stringer S1 at Pier 157 - General view at right side web of stringer. Looking begin left.

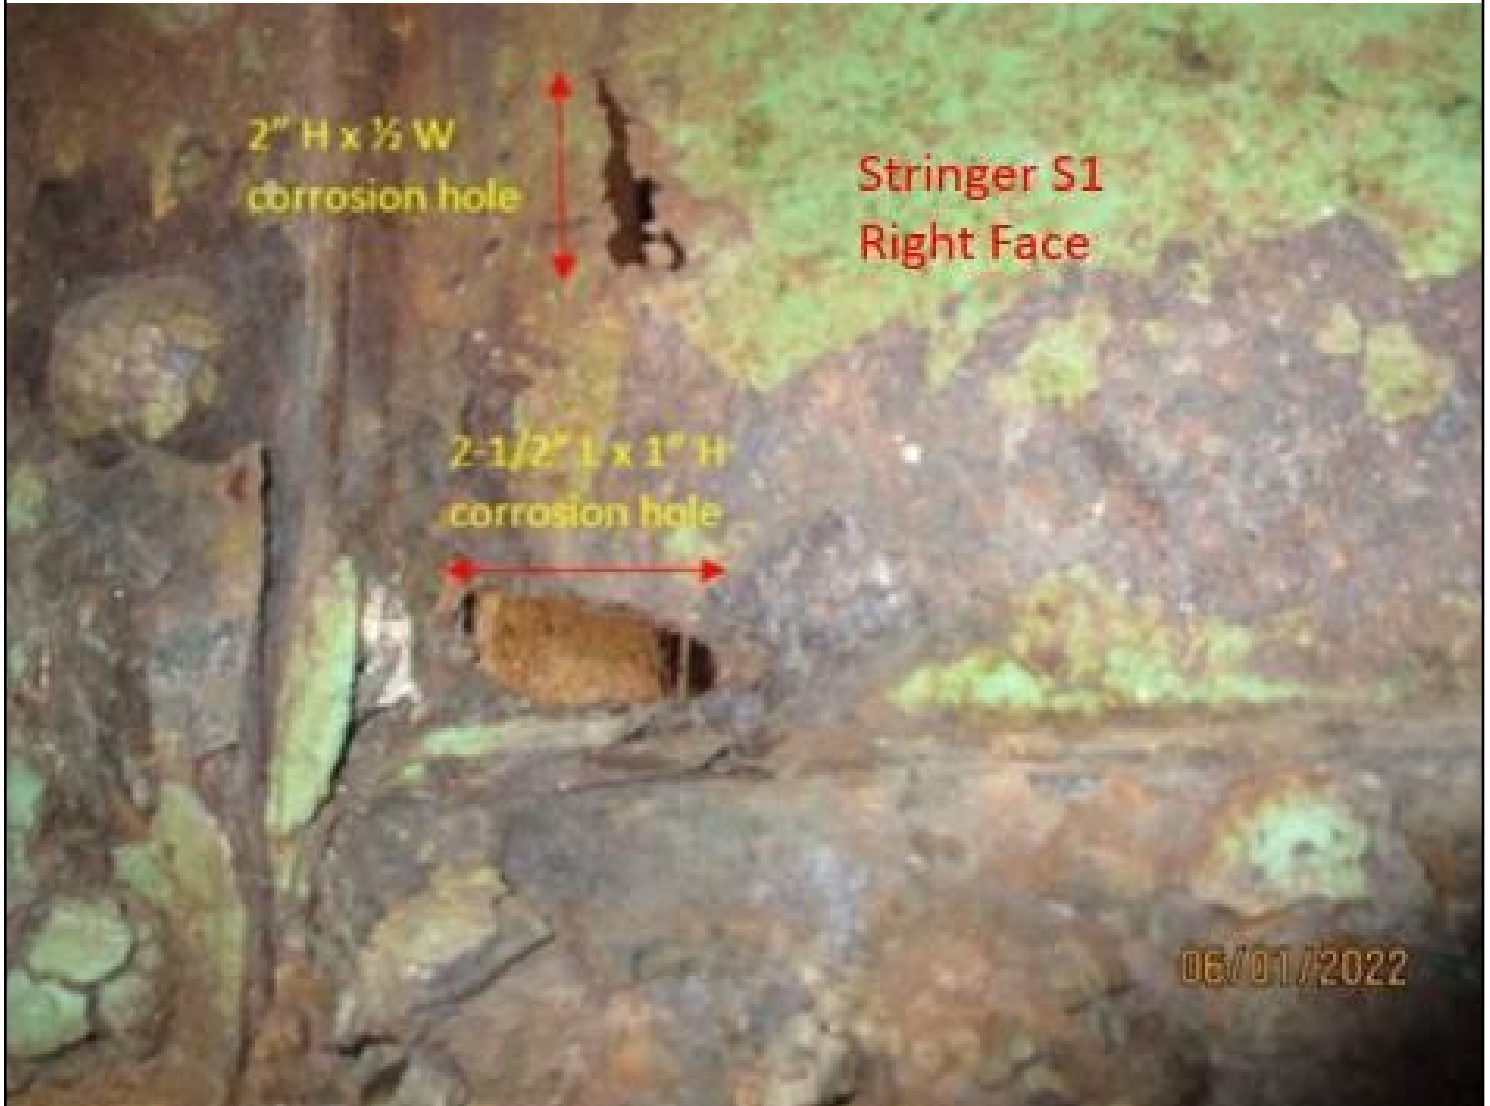
Photo Number: 6

Attachment Description: Photo 4: Span 158, Stringer S1 at Pier 157 - Close up view of corrosion holes at lower section of web measuring 2-1/2"L x 1"H and 2"H x 1/2" wide. Looking left.

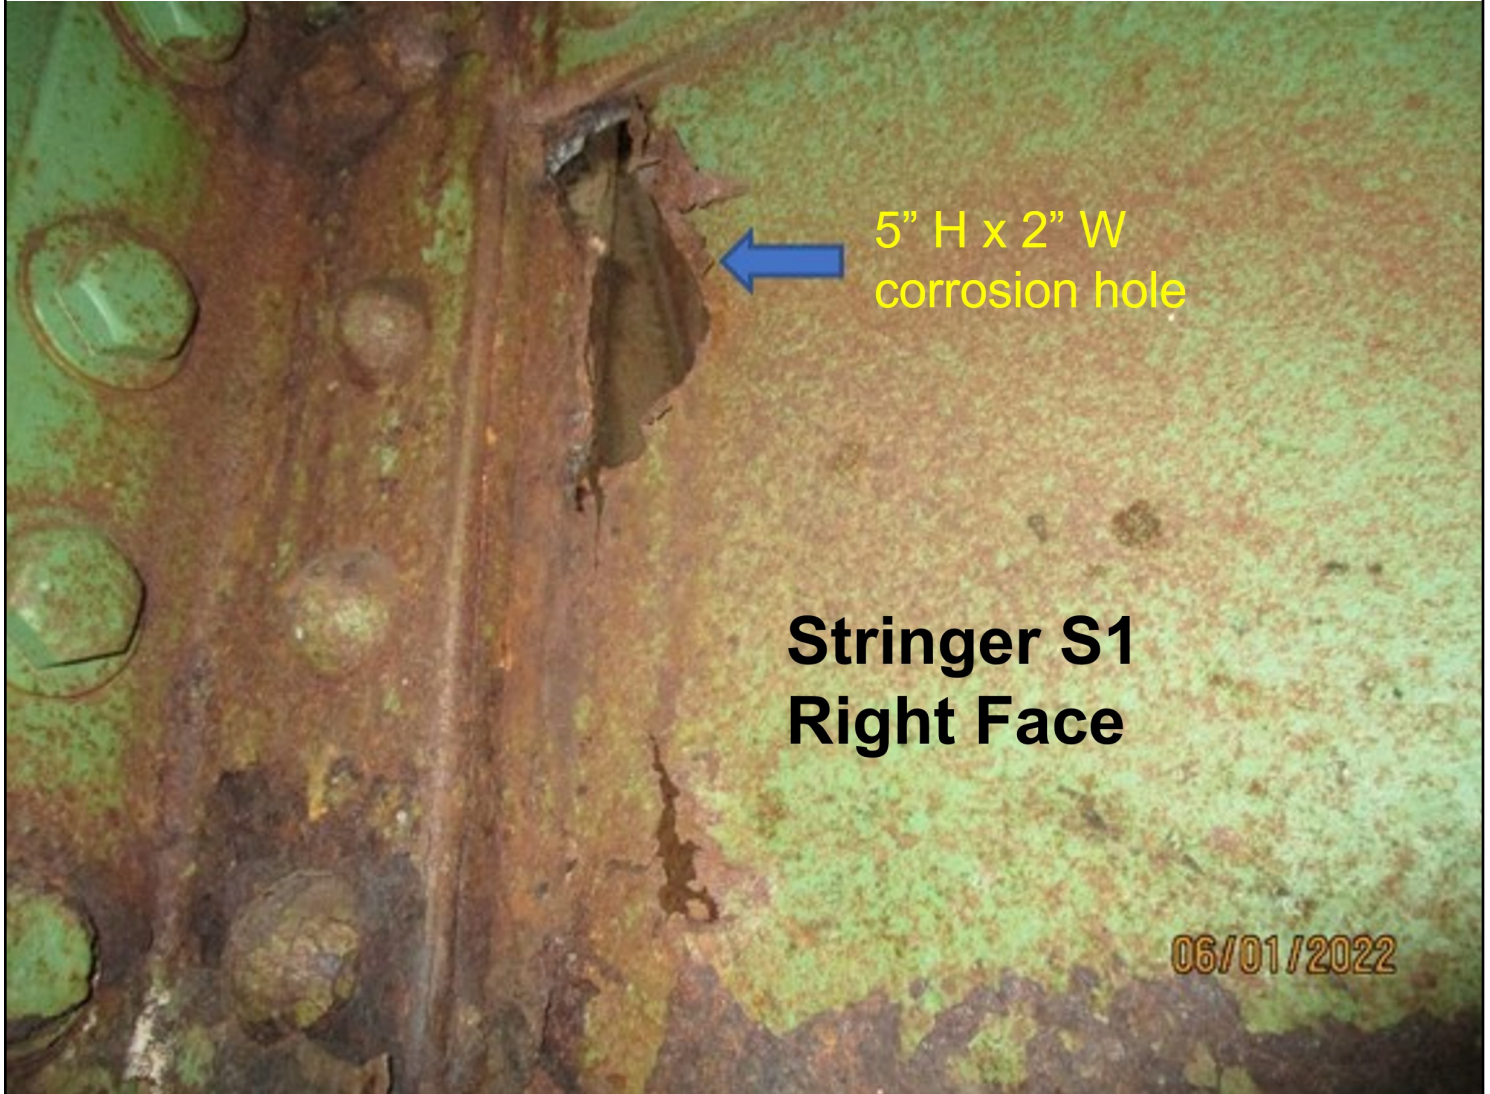
Photo Number: 7

Attachment Description: Photo 5: Span 158, Stringer S1 at Pier 157 - Large corrosion hole at upper section of web measuring 5"H x 2"W. Looking left.
